RICS  
**HomeBuyer Report**

Sample Road  
Sample  
S40 1TX

6th August 2012

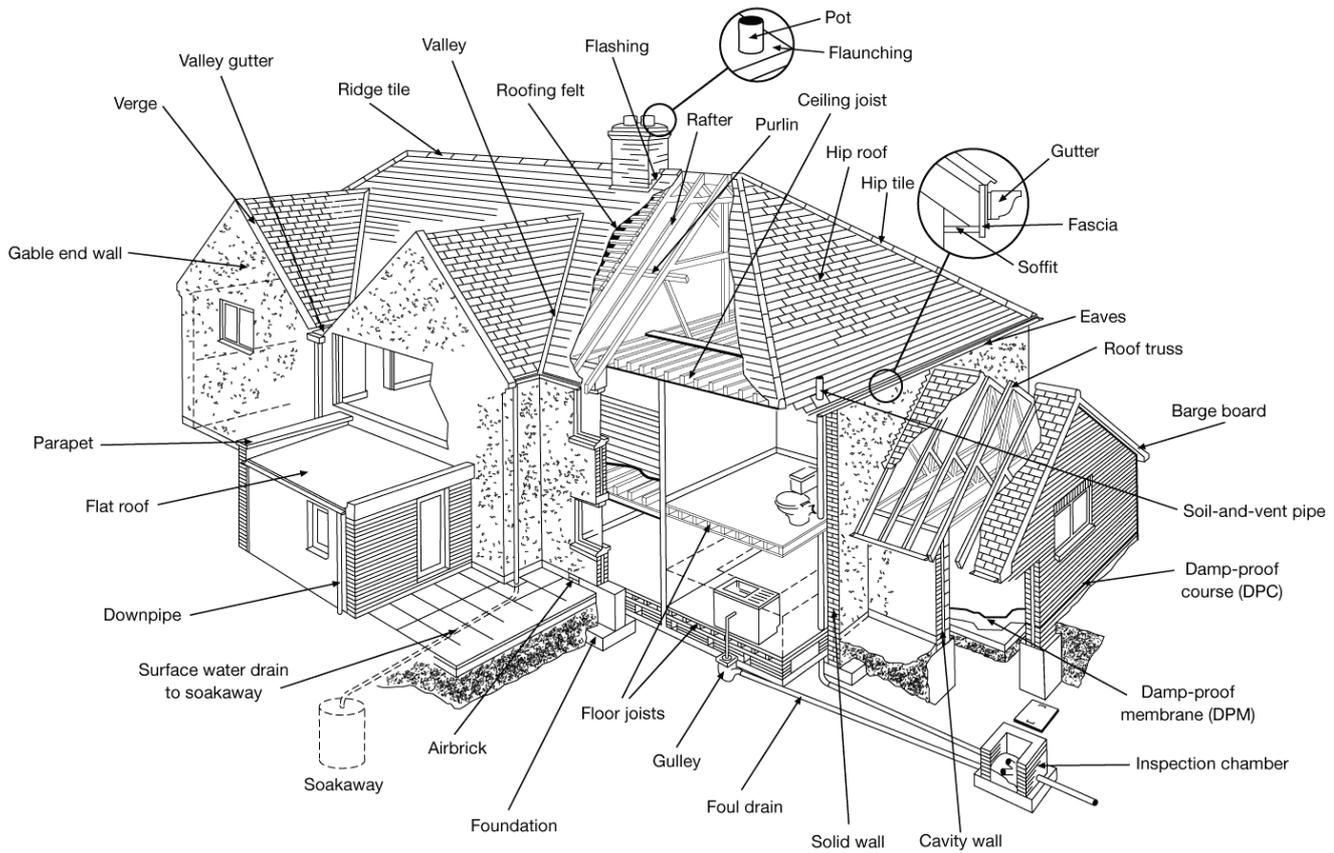
# Typical house diagram

This diagram illustrates where you may find some of the building elements referred to in the report.
